**CWA COMPLIANCE EVALUATION INSPECTION REPORT
U.S. ENVIRONMENTAL PROTECTION AGENCY, REGION 5**

Compliance Evaluation Sampling Inspection

Walworth County

November 17, 2015

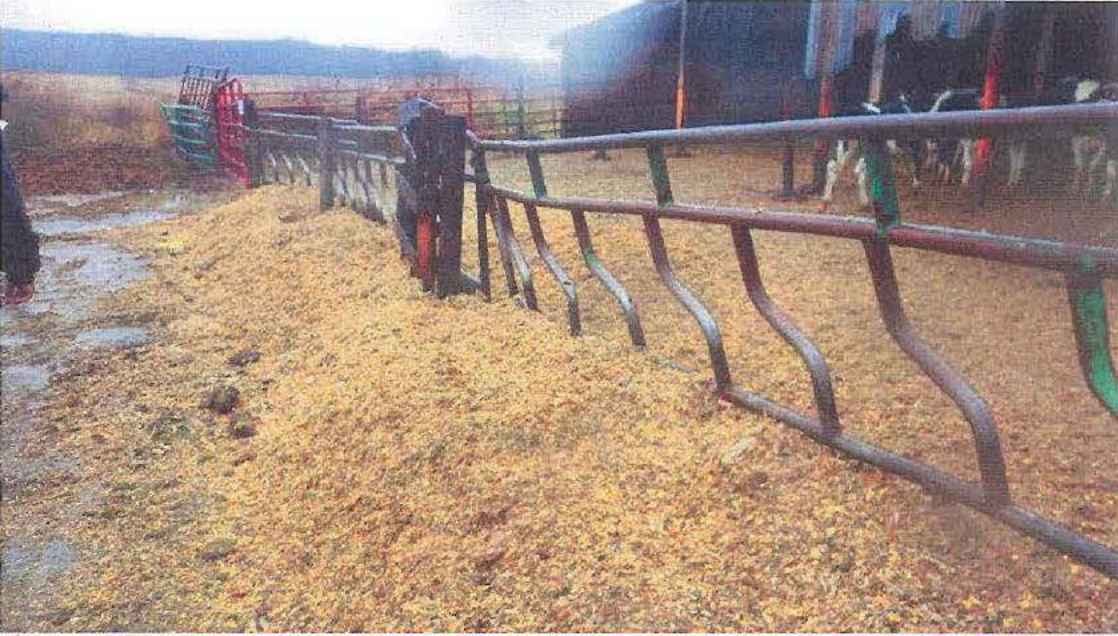
106: RIMG0659

Description: South heifer barn and open pen have no containment for manure and process wastewater.

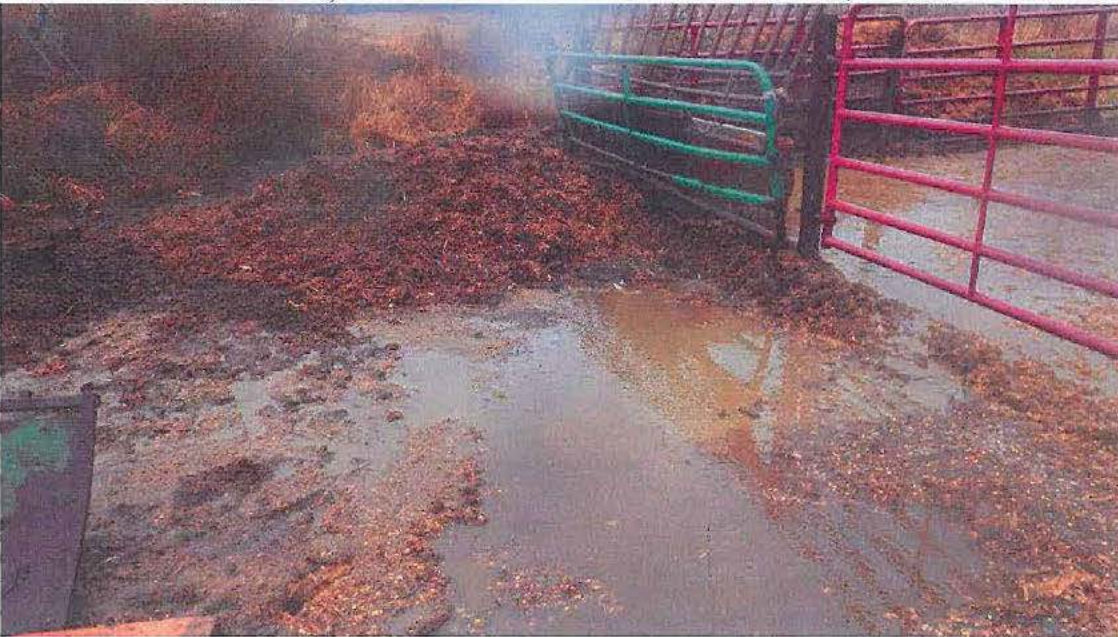
107: RIMG0660

Description: Pile of manure and used feed at the southeast corner of the open pen of the Heifer Barn.

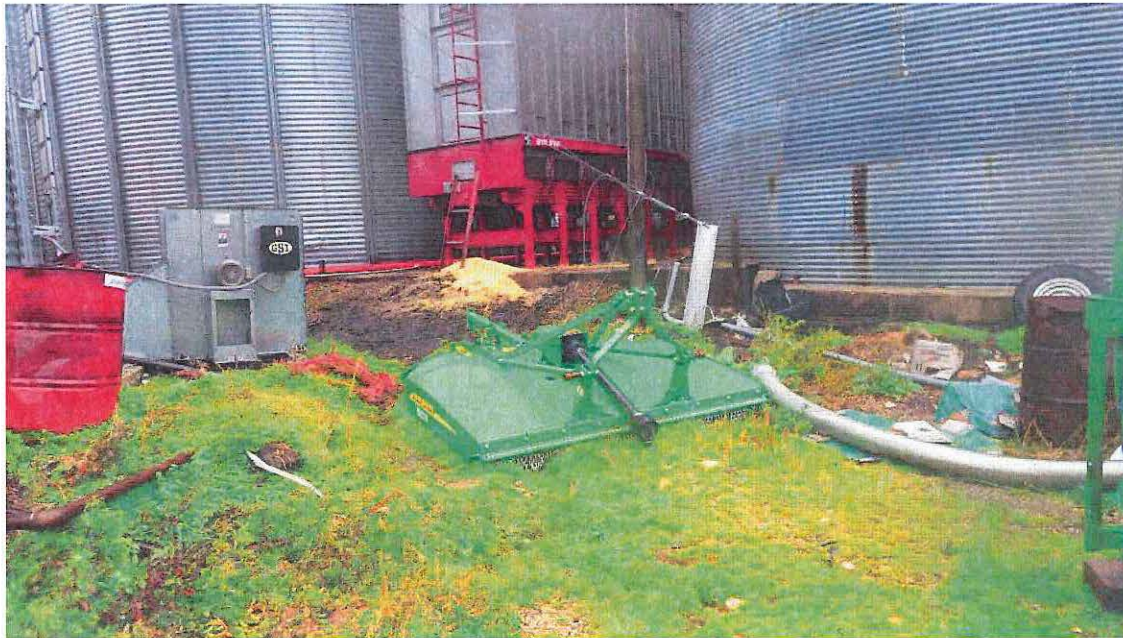
108: RIMG0661

EPA then walked to the north and noted a significant amount of feed on the ground around the grain bins.

Description: Grain spilled around the grain bins.

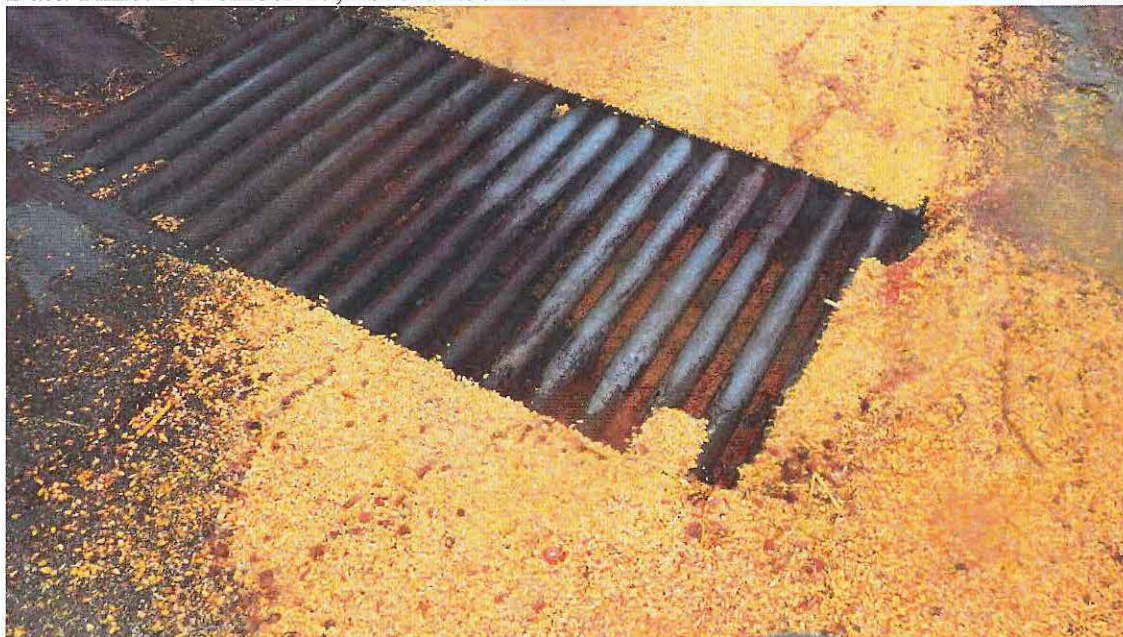
109: RIMG0662

Description: Spilled feed around the grate for the loading auger.

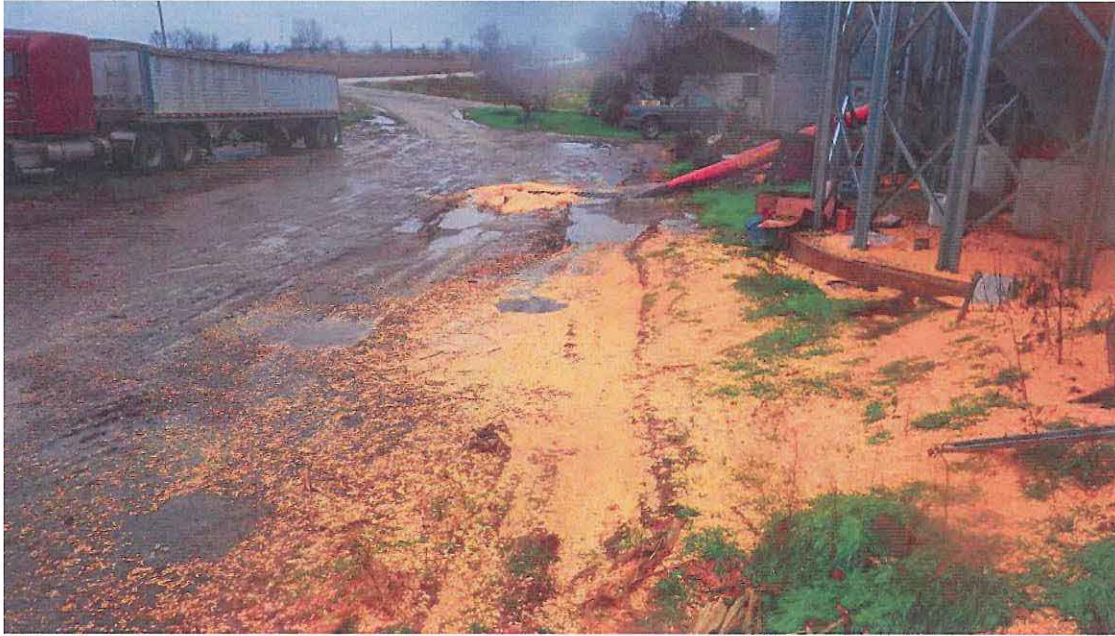
110: RIMG0663

Description: Significant amount of spilled feed around the grain bins.

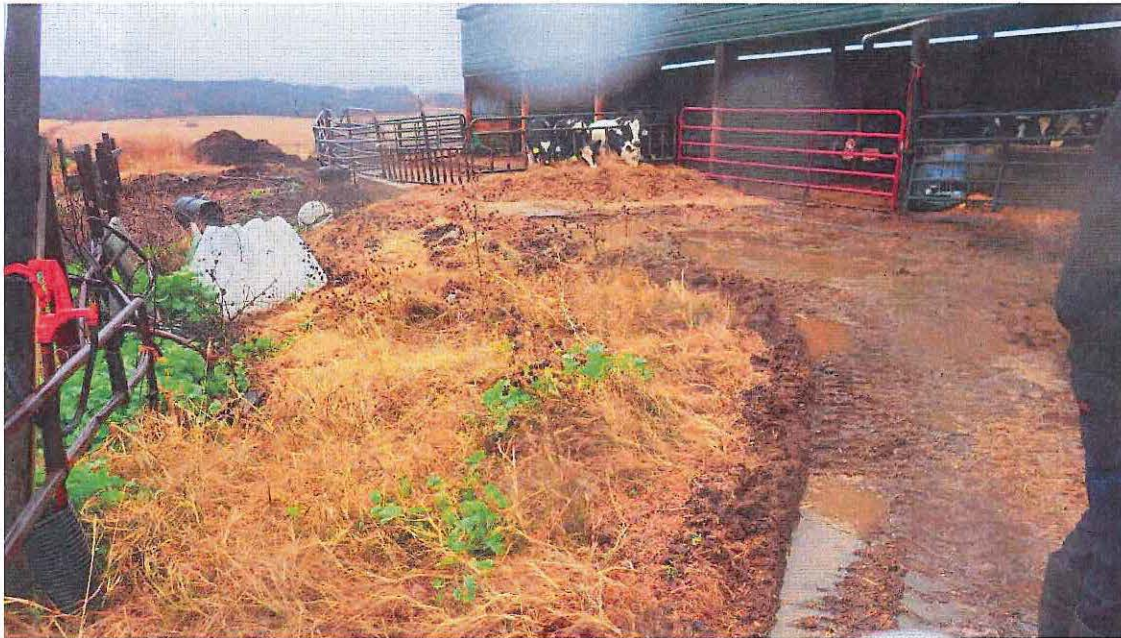
111: RIMG0664

EPA walked north to the heifer barn north of the grain bin and observed that this barn also had an open pen attached to it with no containment for manure, feed, or process wastewater. A pile of manure was stacked outside the open pen. Any runoff of pollutants would flow with precipitation to the west toward a crop field. EPA did not observe any runoff from this barn or the open pen reach a surface water on the day of the inspection.

Description: North heifer barn and open pen have no containment for manure and process wastewater.

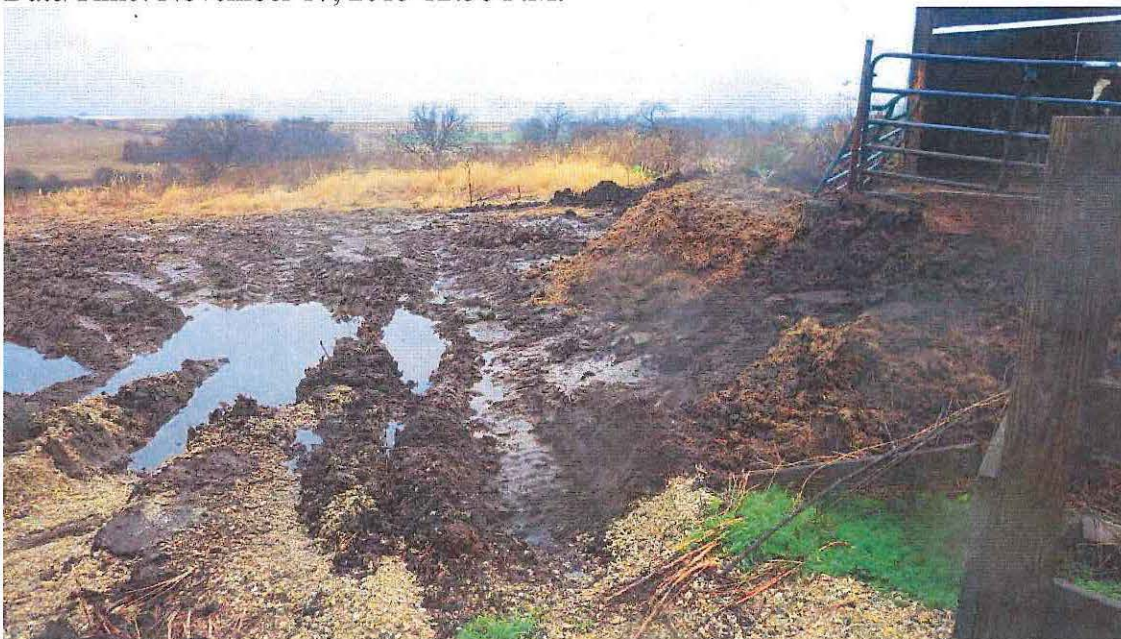
112: RIMG0665

Description: Manure, feed and process wastewater from the north heifer barn is not contained and could flow with precipitation to the south or west.

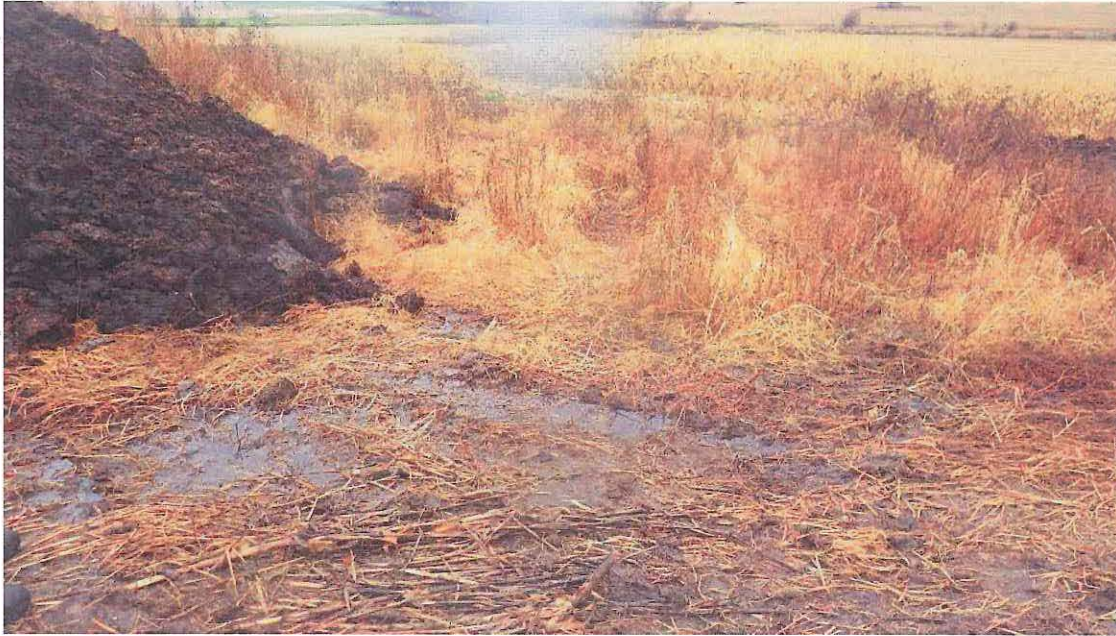
113: RIMG0666

Description: Process wastewater from the manure and feed piled by the north heifer barn is not contained and can flow to the west toward a crop field.

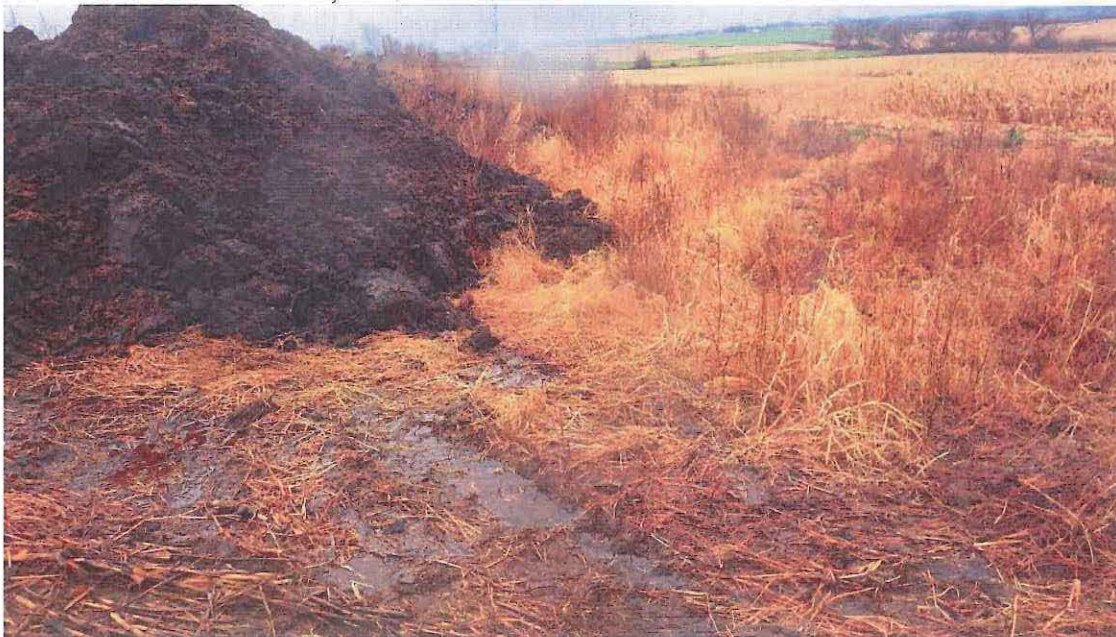
114: RIMG0667

Description: Process wastewater from the manure and feed piled by the north heifer barn is not contained and can flow to the west toward a crop field.

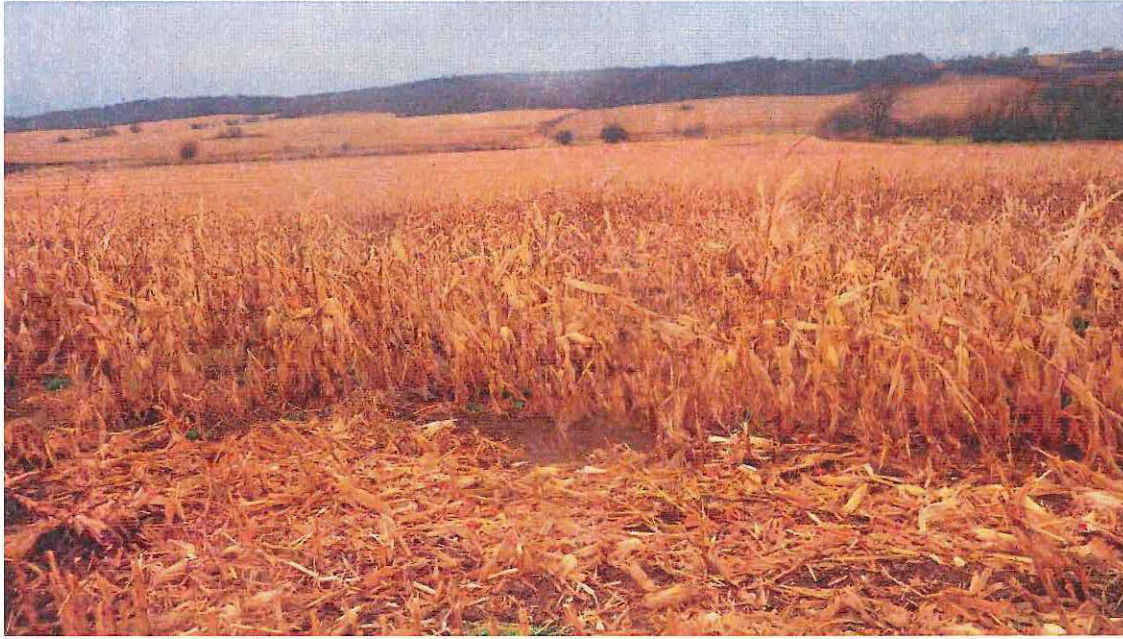
115: RIMG0668

Description: EPA did not observe the process wastewater from the north heifer barn reach a surface water on the day of the inspection.

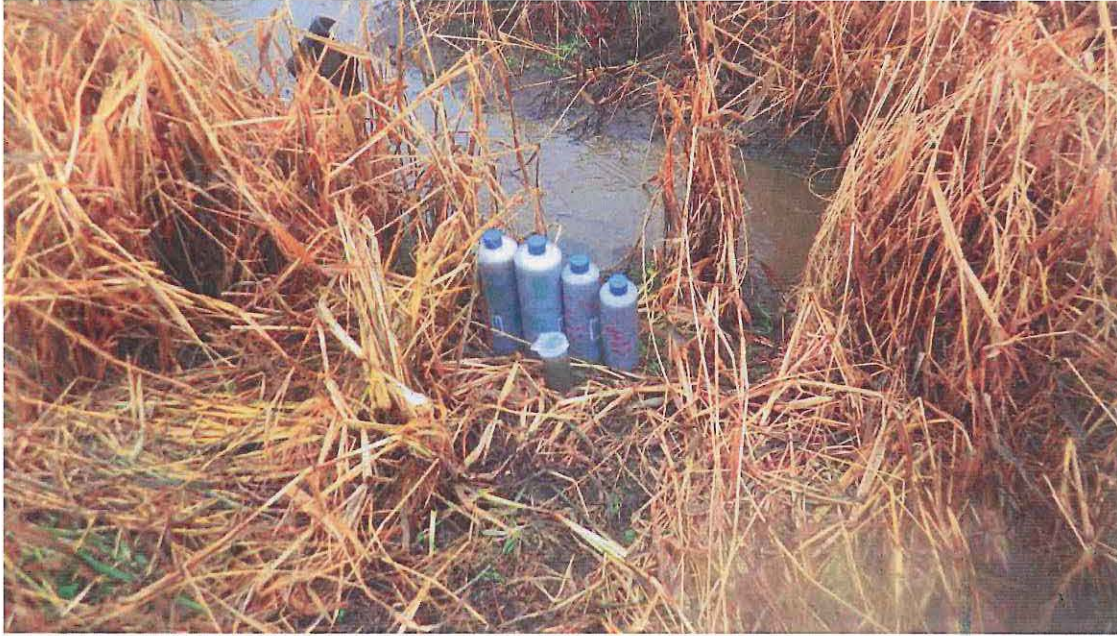
116: RIMG0669

EPA took sample S01, named "Before Ditch", at 1:40 P.M., from the flow channel just before it confluences with the drainage ditch from the east. A sample from this location would have any runoff from the Calf Barn and its open lot, the Heifer Barn north of the Calf Barn and its open lot, the 2000, 2002, and 2004 Freestall Barns and their open lots on the west side, the Calf Hutches, and from the east part of the feed mixing area. Any pollutants from these locations would flow over the ground to this flow channel before flowing into the drainage ditch and then under Highway 120 to the grassed waterway. Storm water from the three pipes south of the Milking Parlor also would aid in the transport of pollutants to this channel.

Description: Sample S01, "Before Ditch", was taken from the flow channel in the yard east of Highway 120 before it flowed into the drainage ditch on the south side of the production area. This flow channel contained runoff from the freestall barns, the calf hutches, and the feed mixing area.

Sample with CRL identification number 1511008-01 (field name: S01) had a final BOD result of 870 mg/L and its batch QC duplicate was 1600 mg/L. This was a relative percent difference (RPD) of 56.7%, which exceeded the RPD control limit of 20%. The final result for sample 1511008-01 (field name: S01) was calculated from an invalid depletion, but the duplicate result was calculated from a valid depletion. Comparing valid and invalid depletions increases the amount of uncertainty in the final results. This was likely caused by a difficult sample matrix that remained non-homogenous even after vigorous preparation. Therefore, the results were flagged as estimated.

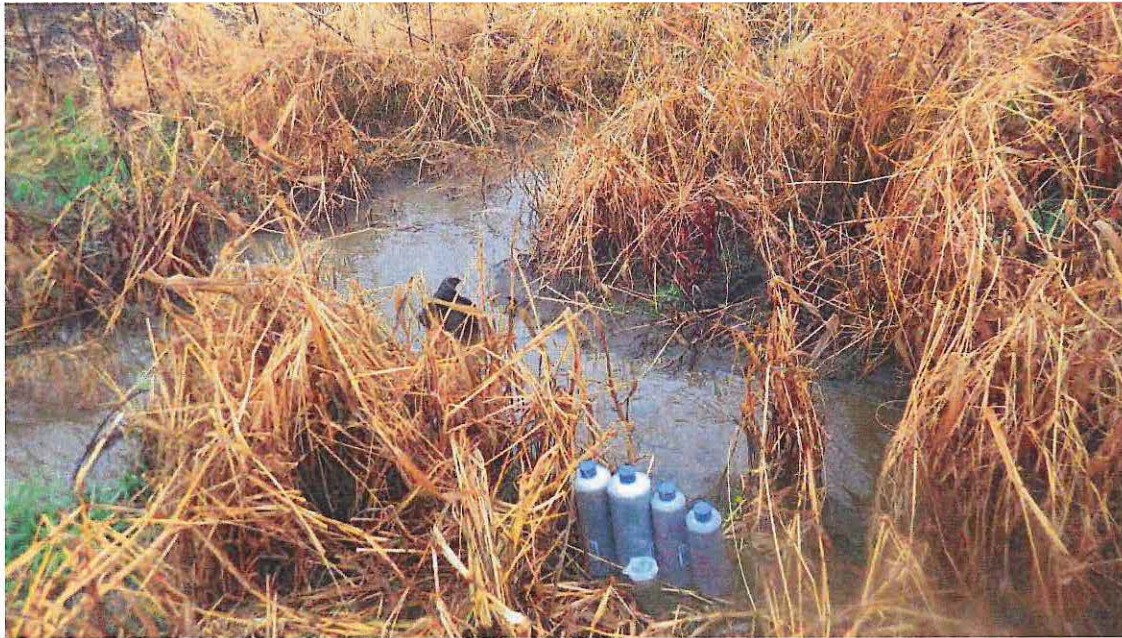
117: RIMG0670

Description: Sample S01, "Before Ditch", was taken from the flow channel in the yard east of Highway 120 before it flowed into the drainage ditch on the south side of the production area. This flow channel contained runoff from the freestall barns, the calf hutches, and the feed mixing area.

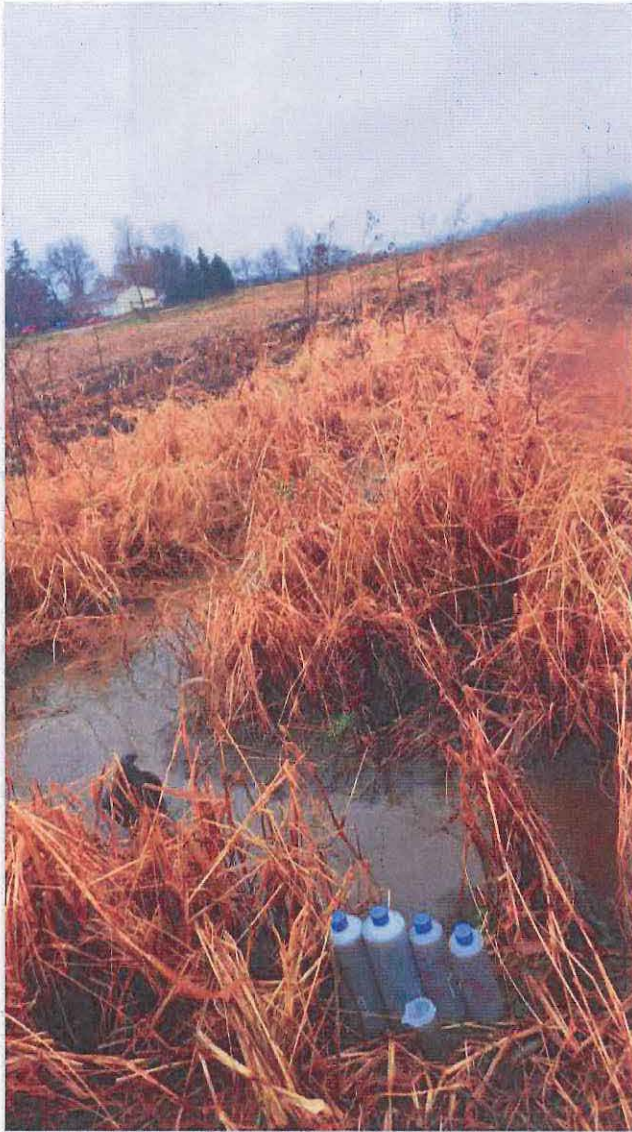
118: RIMG0671

Description: Sample S01, "Before Ditch", was taken from the flow channel in the yard east of Highway 120 before it flowed into the drainage ditch on the south side of the production area. This flow channel contained runoff from the freestall barns, the calf hutches, and the feed mixing area.

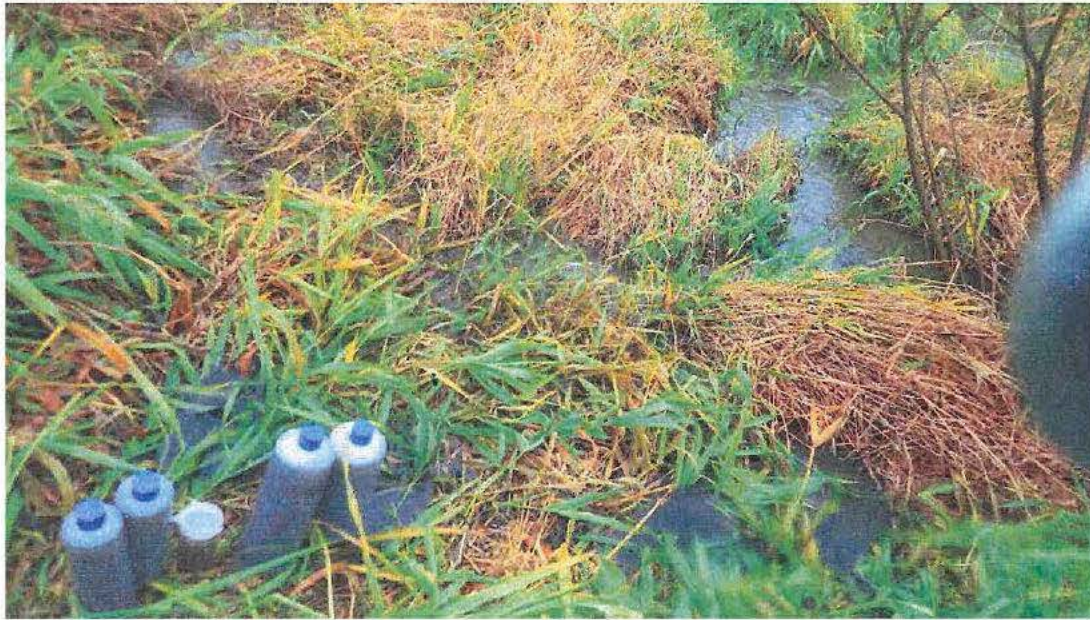
119: RIMG0672

EPA crossed over Highway 120 to take the second sample, named "West Ditch", at 1:54 P.M. from the channel in the grassed waterway. If there was pollutants in this sample, it would indicate that the facility had not prevented the pollutants from leaving the production area and that pollutants had reached the grassed waterway. EPA went approximately 50 feet into the grassed waterway for this sample.

Description: Sample S02, "West Ditch", was taken from the flow in the grassed waterway on the west side of Highway 120 after going under Highway 120 through a culvert.

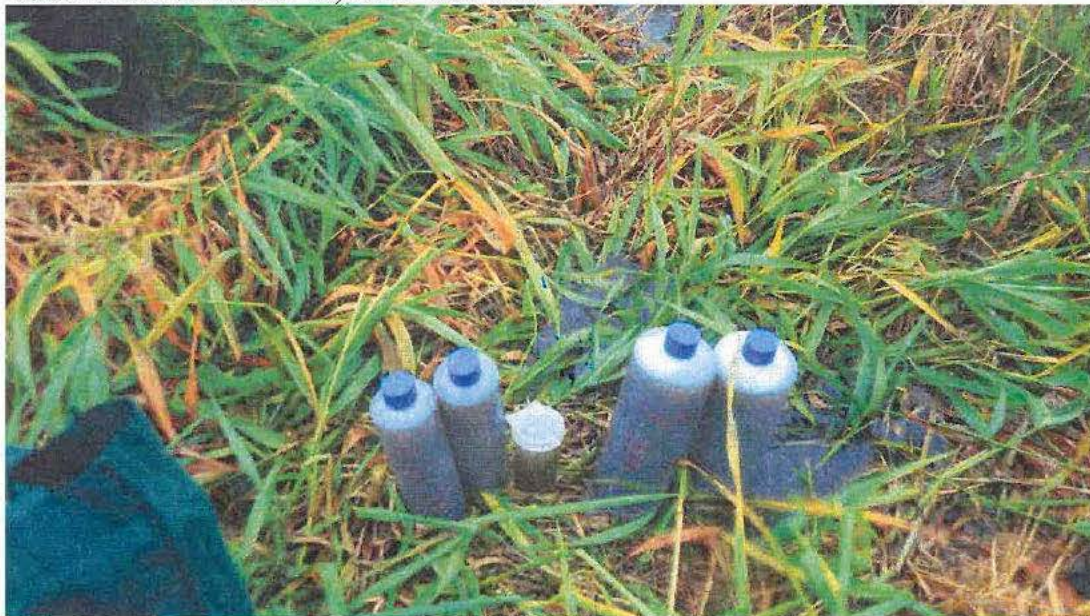
120: RIMG0673

Description: Sample S02, "West Ditch", was taken from the flow in the grassed waterway on the west side of Highway 120 after going under Highway 120 through a culvert.

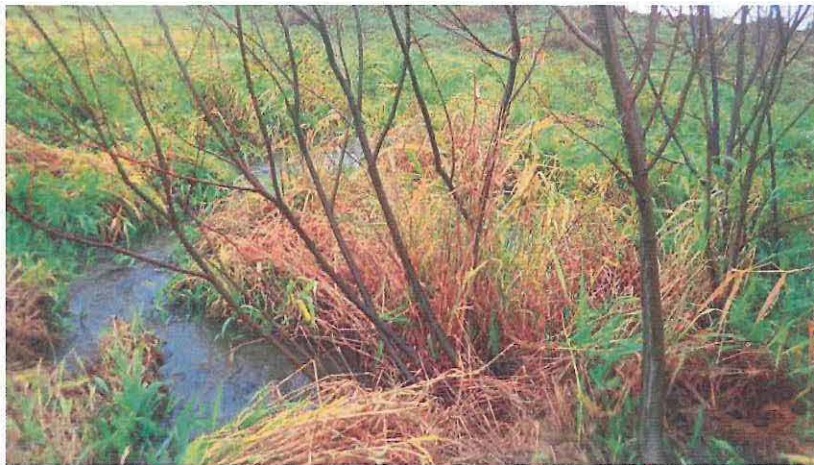
121: RIMG0674

Description: The flow in the grassed waterway before where Sample S02 was taken.

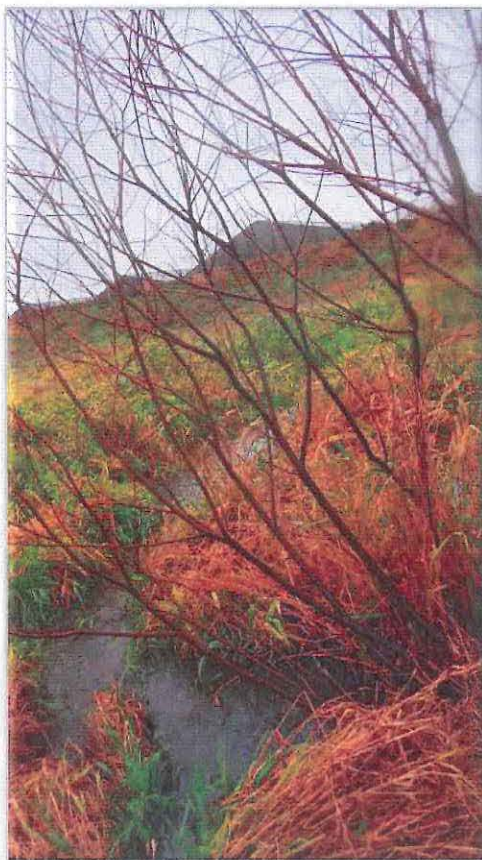
122: RIMG0675

Description: The flow in the grassed waterway before where Sample S02 was taken.

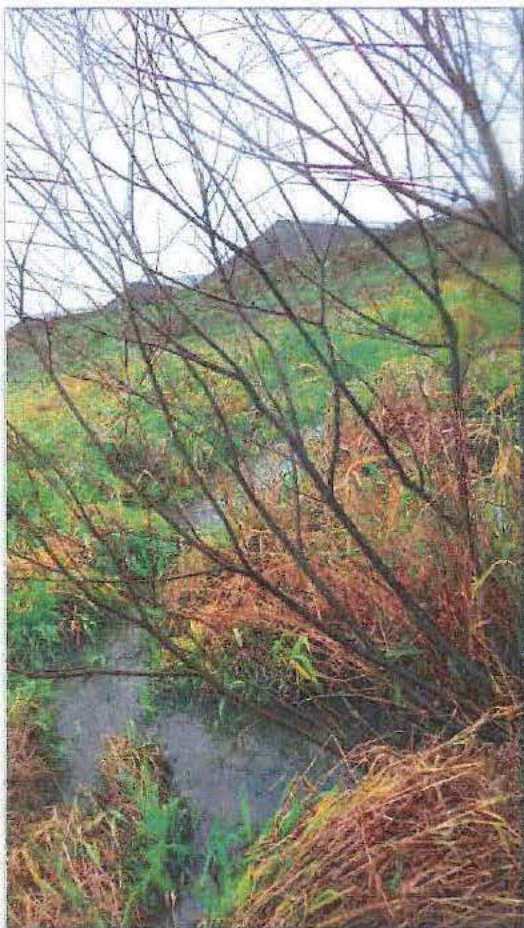
123: RIMG0676

Description: The flow in the grassed waterway before where Sample S02 was taken.
